Appendix 14-B

Descriptions of On-Site Streams

Appendix 14-B
CPV Valley Energy Project
Description of On-site Streams

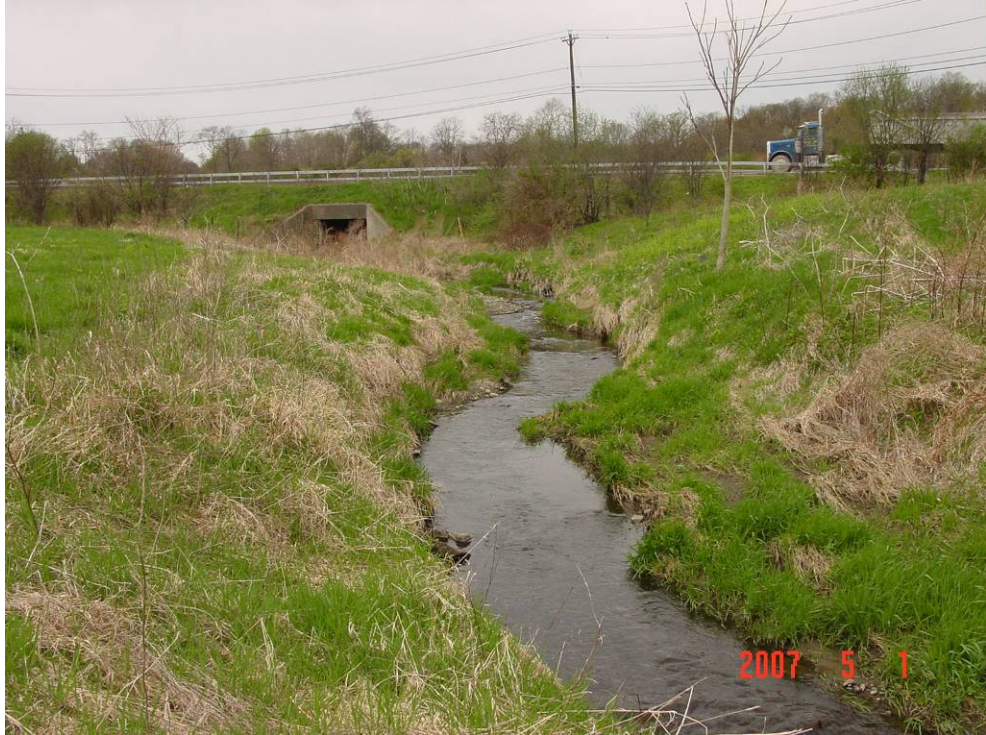
PHOTO 1. Reach 1, Carpenter Creek upstream view to west with Route 6 in background.

Reach 1 of Carpenter Creek is relatively uniform in width, depth and flow velocity from its entry point on the site (Route 6 culvert) (photos 1 and 2) to where it joins Reach 2 of Carpenter Creek and the southern tributary stream (Reach 3) (photo 3). The main channel of Reach 1 is approximately 4 to 6 feet wide and ranges from 4 to 6 inches in depth during normal flow periods (observed in the months of January, May and July). Channel flow is typically 0.5 to 1 foot per second within this reach of the channel. The channel bed contains mostly sand and gravel, with frequent cobbles both below and above the water surface. The banks are generally steep, 2:1 slopes and average 4 feet in height above the mean water line. It appears that the channel has been dredged and straightened in the past due to the presence of dredge spoils along portions of the banks (including a raised road in one area) and the relatively straight lines of the channel as it passes through the adjacent hayfields. Several man-made drainage channels join the

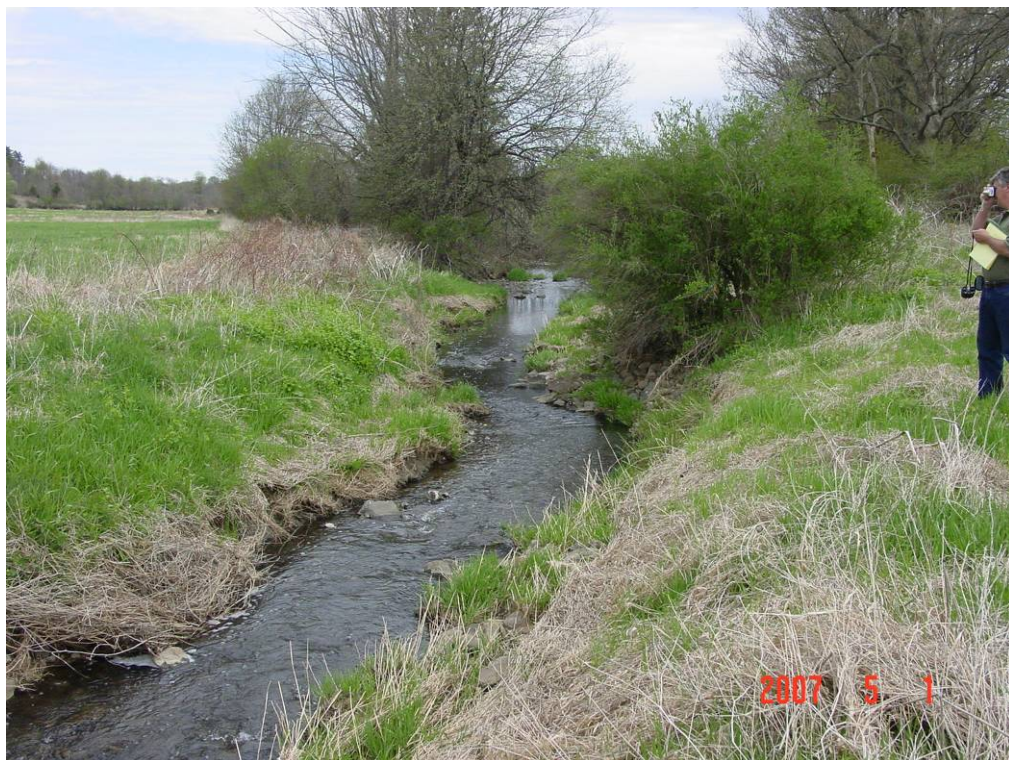
PHOTO 2. Reach 1, Carpenter Creek downstream view to east (180 deg. opposite from photo 1).

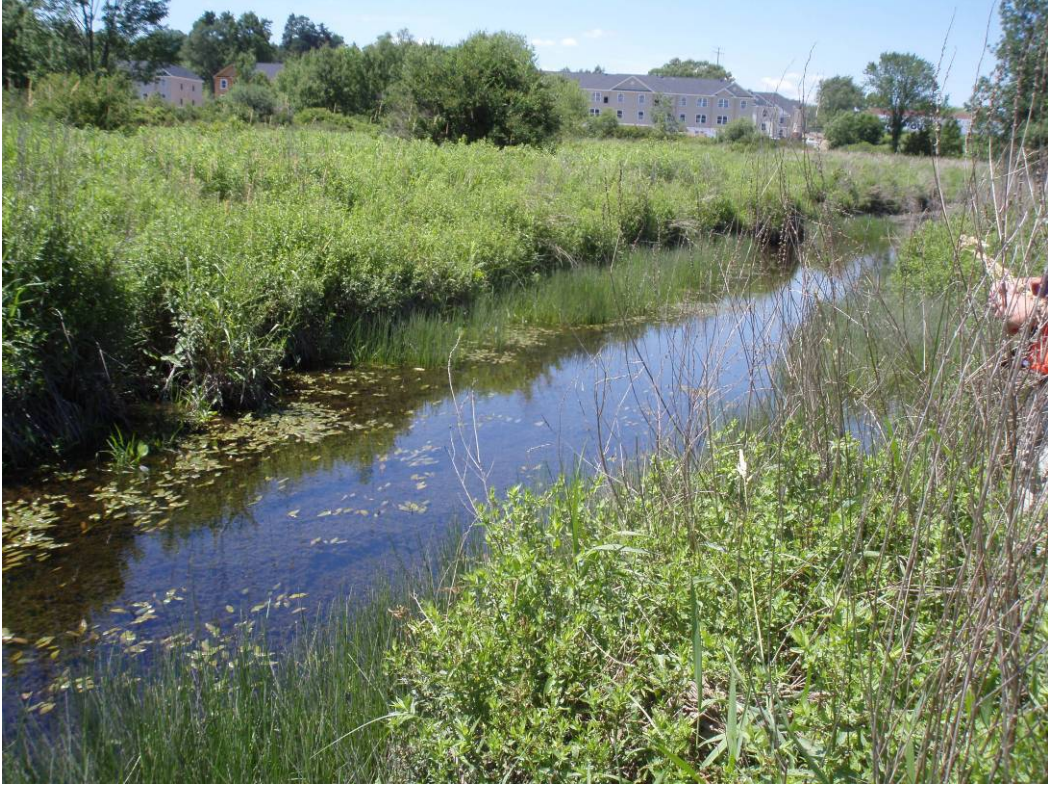
PHOTO 3. Reach 1, Carpenter Creek downstream near confluence with Reach 2, view to northeast.

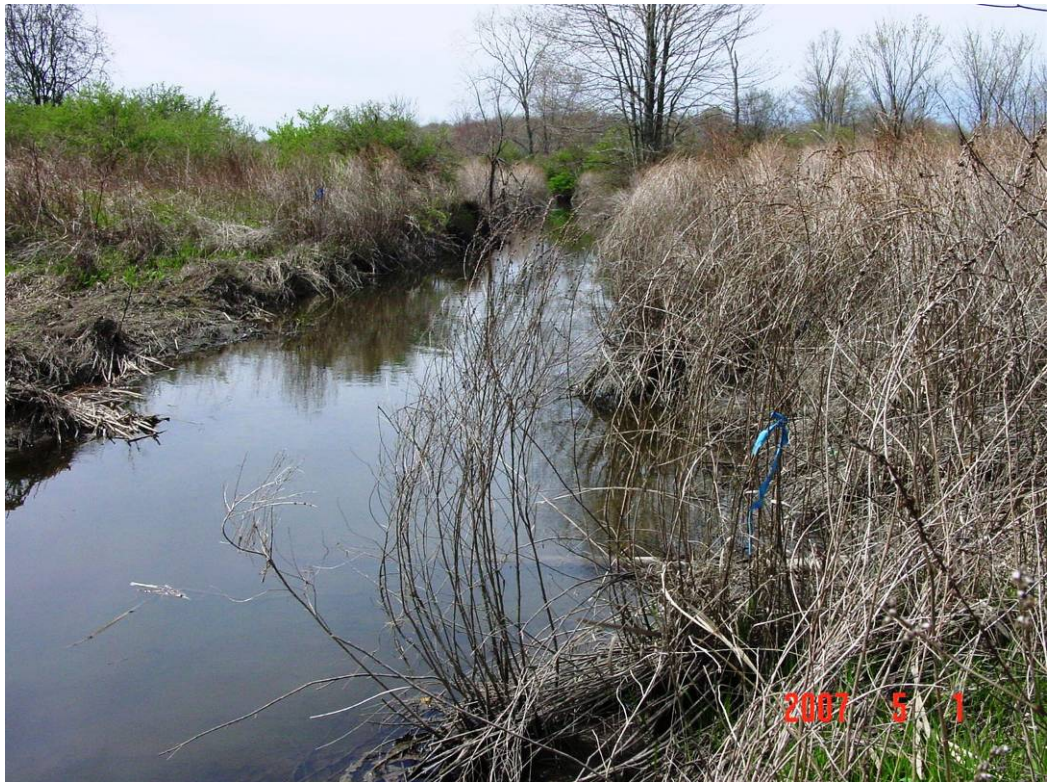
PHOTO 4. Reach 2, Carpenter Creek upstream view to southwest.

As Carpenter Creek flows east, passing through forested/shrub wetland and then wet meadow communities, it slowly broadens and slows its velocity. At the confluence of Reach 2 and 3, where Carpenter Creek is joined by the southern tributary stream, approximately 700 feet before reaching the Rt. 17M culvert, the channel broadens to approximately 10 to 12 feet in width and 6 to 10 inches in depth (photo 4). Here the velocity is typically 0.1 to 0.5 feet per second, with almost no noticeable flow. The channel bottom is mostly silt and mud, with communities of aquatic weeds present. The channel banks are 1 to 1.5 feet in height and nearly vertical, with gently sloping meadow/marsh and shrub swamp community beyond. Over the last 20 foot length of the stream where it enters the culvert at Route 17M, the stream broadens to approximately 15 feet in width. The culvert at Route 17M is an approximately 10 ft. wide by 8 ft. high, open-bottom concrete box culvert with concrete wingwalls (photo 5).

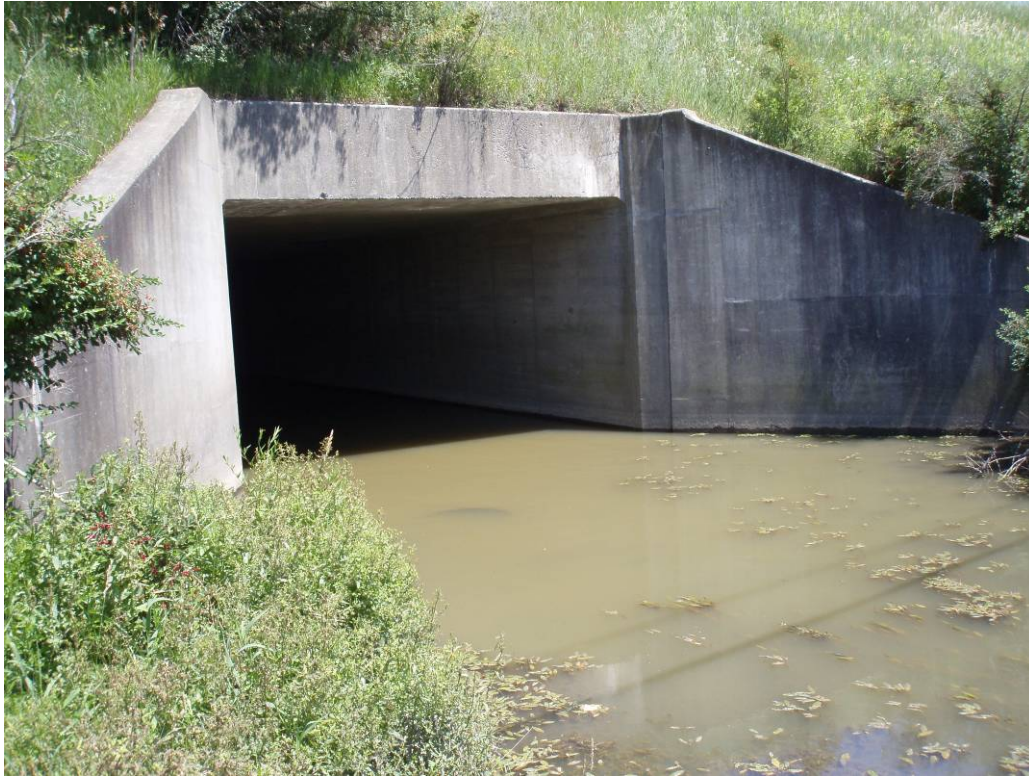
PHOTO 5. Reach 2, Carpenter Creek downstream concrete box culvert at Route 17M, view to east.

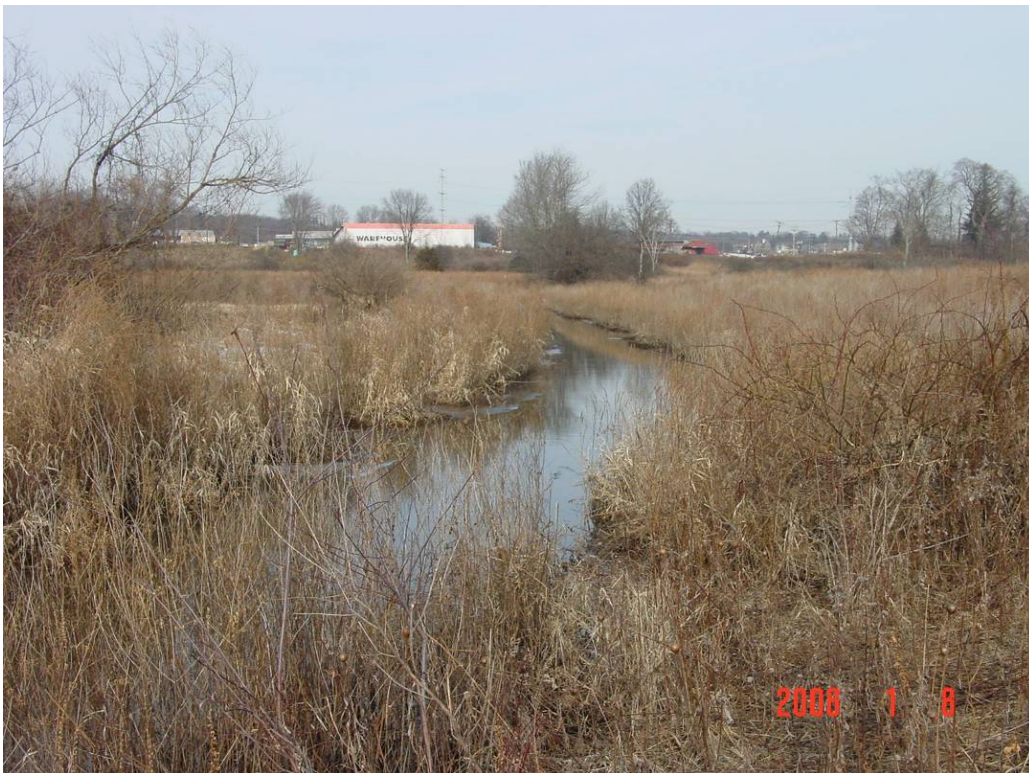
PHOTO 6. Reach 3, southern tributary stream downstream view from I-84 to north.

The southern tributary stream enters the site from a culvert within the I-84 right-of-way. From the culvert it flows approximately 1,000 feet northeast, parallel to the I-84 west-bound on-ramp, and then veers north into the site. This channel is typically 10 to 12 feet wide and 6 to 10 inches deep (photo 6). Flow velocity is 0.1 to 0.5 inches per second. Like Reach 2, the banks of this segment are nearly vertical and 1 to 1.5 feet high, with an adjacent wet meadow/shallow marsh community.

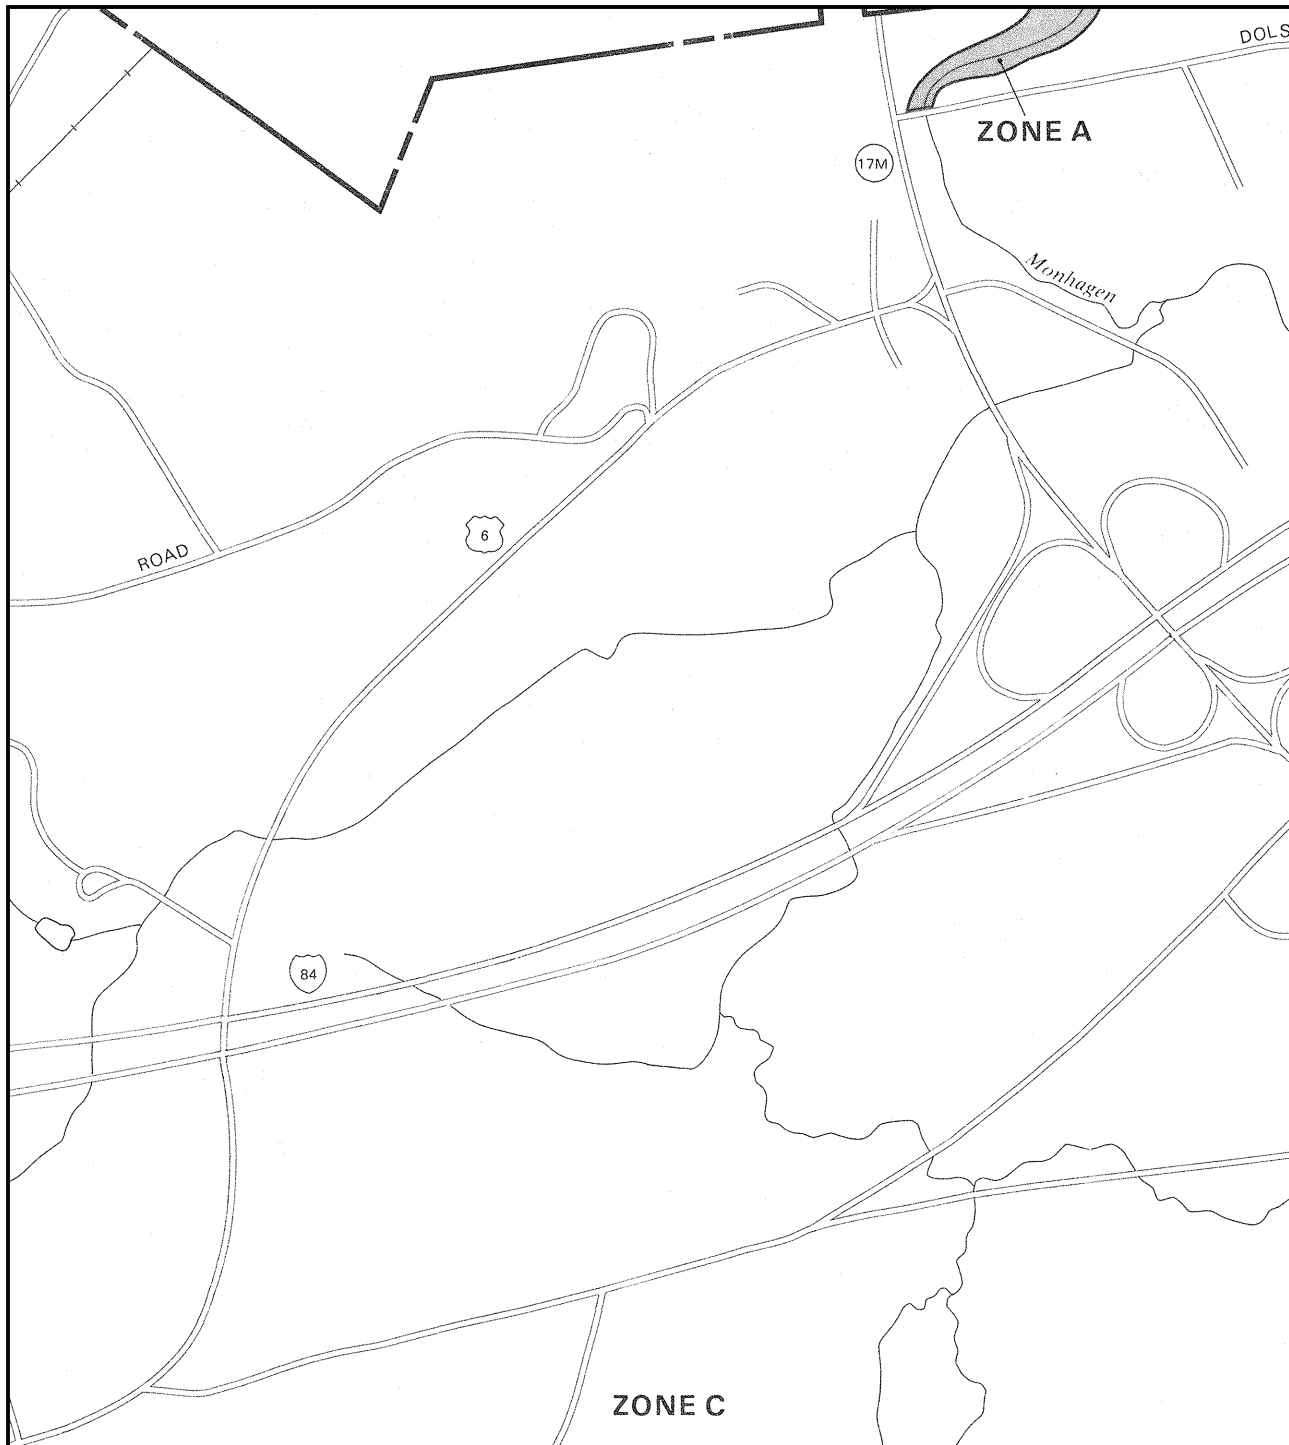
COMMUNITY-PANEL NUMBER
360639 0010 B

According to the Federal Emergency Management Agency (FEMA) Flood Insurance Rate Map (FIRM) for Wawayanda Township, New York (Community Panel No. 360639 0010B) (map of site portion attached), the 100-year floodplain has not been mapped for the on-site streams.
